South Carolina Statewide Survey Site Form
State Historic Preservation Office
P.O. Box 11669 • Columbia • SC • 29211 • (803) 734-8609

1. Control Number U 35 / 1390 / 496 0470.01 2. NR Microfiche index # _____
county census designated place site #
 3. Historic name(s): St. Barnabas Mission Chapel
 4. Common name: Bishop Pengelley Memorial Chapel
 5. Address/location: 705 South Main St.
 City: Summerville Vicinity of: _____ County: Dorchester TMS: 137-10-07-04

South Carolina Statewide Survey Site Form
CONTINUATION AND PHOTOGRAPHS

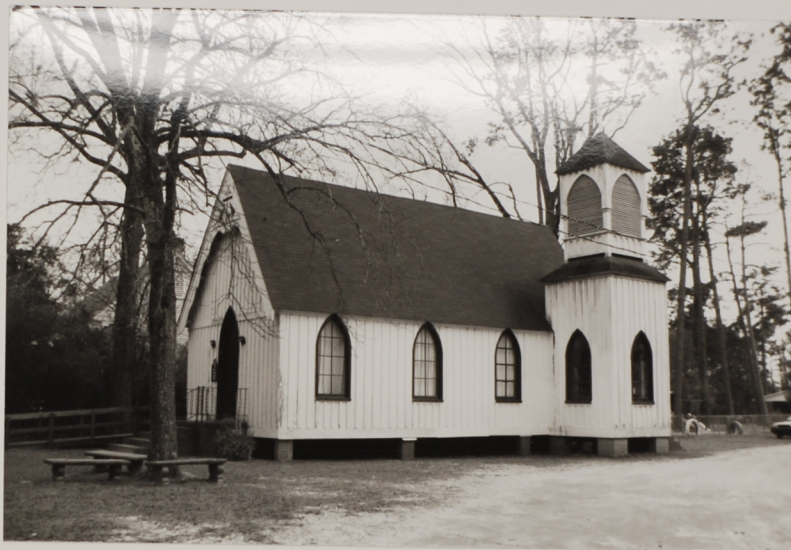
Photo #	Photo Index #	View of	N, S, E, W
1	D9, F3	Facade & Right	N
2	D9, F2	Rear	S

20. ADDITIONAL DESCRIPTIVE COMMENTS: 8&9: Church. I: Windows are pointed and fixed with eight panes. J: Pointed door surround. L: Board-and-batten siding.
Decorative bargeboard in gable. Square tower to rear of right elevation (Cont.)

20: includes belfry and pyramidal roof. Rear gable wing.

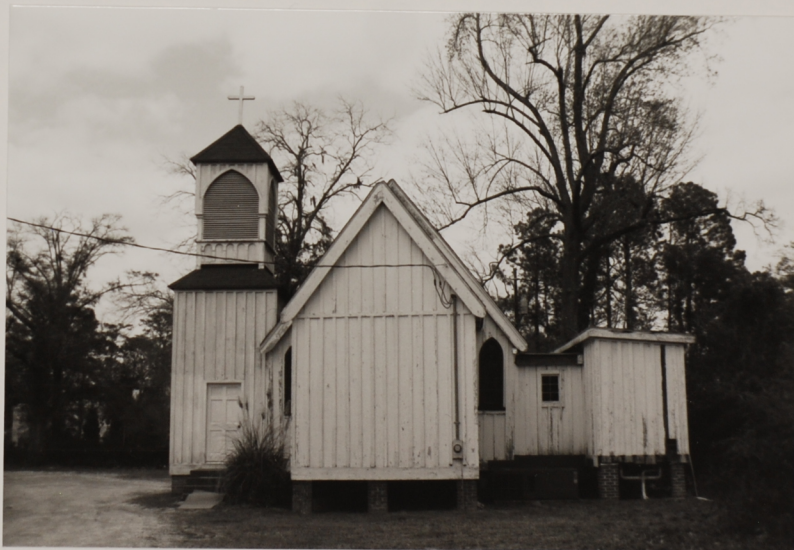
21. ALTERATIONS One by one bay shed addition to rear left is attached to church by shed connector. Structure has been relocated twice: in ca. 1950 out of the way of widened Highway 78, and in 1982 to present site.
