South Carolina Inventory of Historic Places  
 Survey Field Documentation Form  
 State Historic Preservation Office  
 P.O. Box 11-200, Columbia, SC 29201  
 (803) 734-3827

2. ADDRESS NUMBER: L-Orin Hall House

4. COMMUNICATOR: 438 College Ave.

5. CITY: Rock Hill STATE: SC COUNTY: York

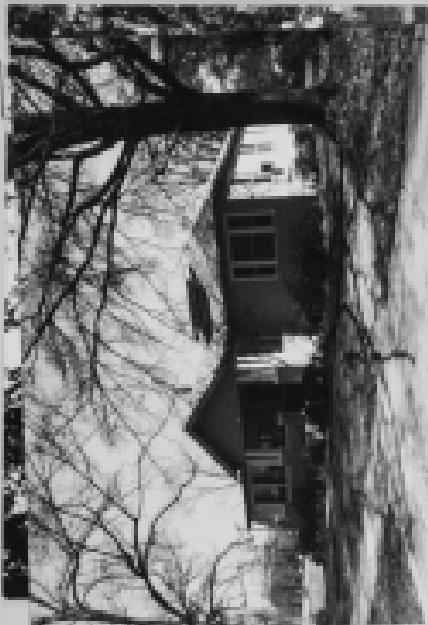
DETAILS  
EXTERIOR (FRONT ELEVATION)

53. ADDITIONAL DESCRIPTIVE NOTES: Batticred composition shingle roof, hipped with side gables and gable porch. Wood shingles in gable ends. Painted tapered wood porch posts. Small shed dormer with paired multi - light window. Windows are 8/1 at facade, 6/1 at side elevations.

54. ALTERNATIVES: Sunporch at left elevation infilled. Aluminum storm door and windows
