South Carolina Inventory of Historic Places
Survey Field Form/Data Entry Form
State Historic Preservation Office
PO Box 11,669, Columbia, SC 29211
(803) 734-8577

1. CONTROL NUMBER: U / 91 / 1195 / 424 - 327
county census design- rated place site number

2. HISTORIC NAME(S): Willis D. Magginnis House

4. ADDRESS/LOCATION: 520 Aiken Ave.
PARCEL# 6290606004

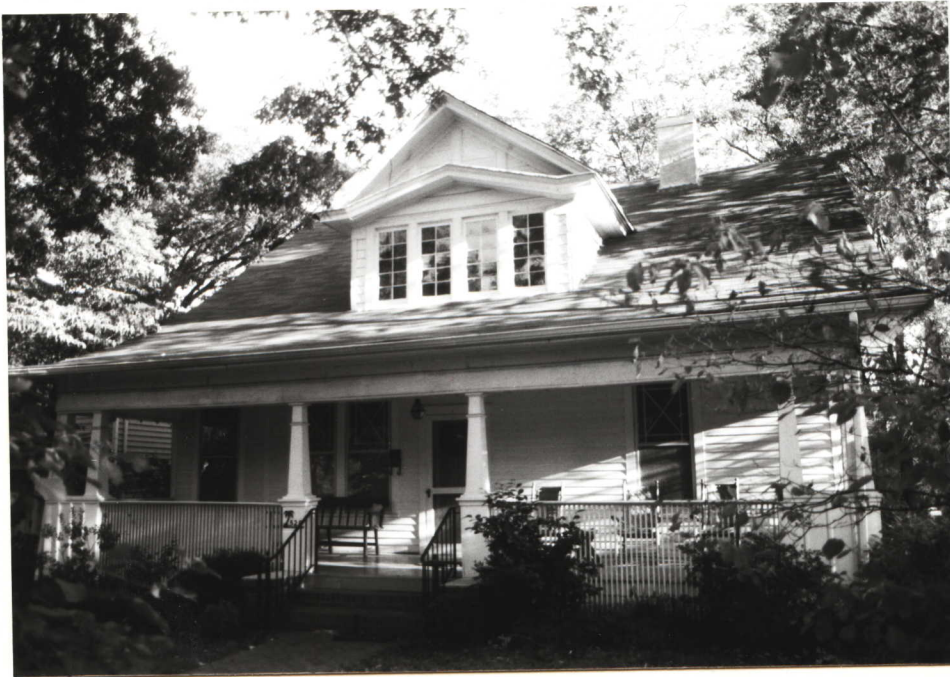
View of  
FACADE - NORTH ELEVATION

20. ADDITIONAL DESCRIPTIVE COMMENTS Porch with single and paired tapered wood posts on wood pedestals. Single and double BCG windows; large pedimented gable dormer with four tall multi-light windows. Brick pier foundation with brick infill; lot slopes at rear: full raised basement. Right elevation has slight hipped projection, with three BCG windows; four tall multi-light windows above, in side gable end. Left elevation: double window, projection with tripartite window; four tall multi-light windows in gable end. Hipped rear extensions.

21. ALTERATIONS Rear shed porch, with insect screening, added above rear raised basement. Rear exterior brick chimney. Recent metal handrail at porch, aluminum storm doors and windows.
