South Carolina Inventory of Historic Places
 Survey Field Form/Data Entry Form
 State Historic Preservation Office
 PO Box 11,669, Columbia, SC 29211
 (803) 734-8577

3. OTHER NAME: Ark of the Covenant

4. ADDRESS/LOCATION: 619 Aiken Ave.
PARCEL# 6290603011

CITY: Rock Hill VICINITY OF: _____ COUNTY: York

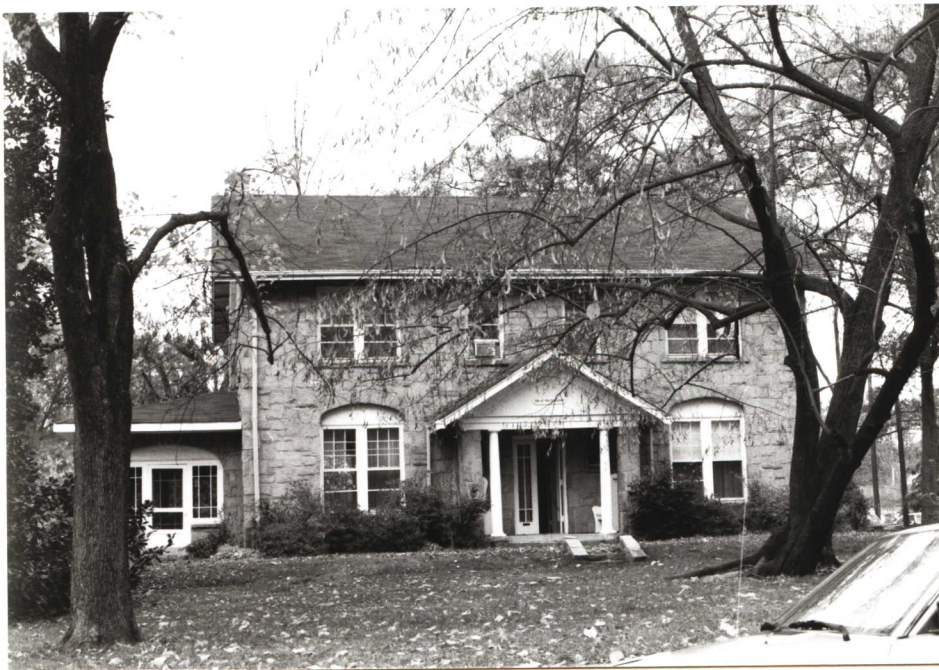
View of
FACADE - NORTH ELEV.

20. ADDITIONAL DESCRIPTIVE COMMENTS First level facade windows set in rounded arches with stuccoed panels. One-story hipped sunporch at left elevation has entry door and sidelights set in similar rounded arch. Tapered wood columns and stone piers at entry porch.

21. ALTERATIONS Aluminum storm windows
